DOT/FAA/RD-91/1

**Composite Profiles of  
Helicopter Mishaps at  
Heliports and Airports**

January 1992

Final Report

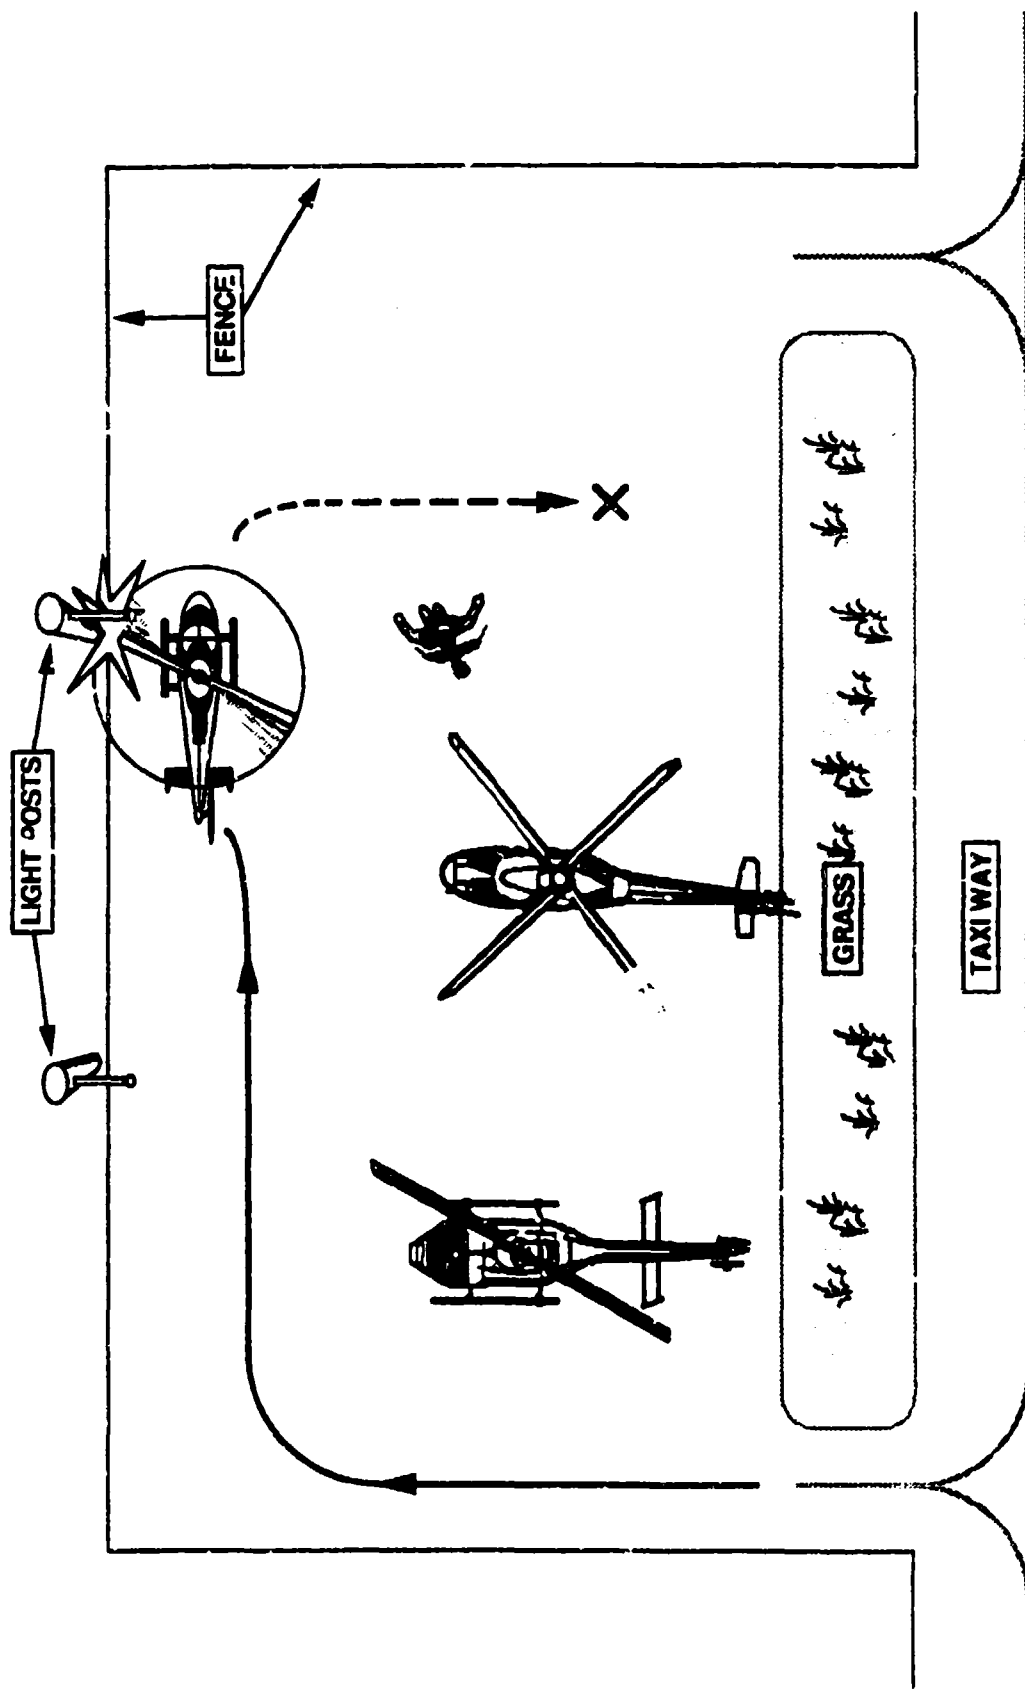
FIGURE 2 OBSTACLE STRIKE - LIGHT POLE

Weather - The weather was definitely a contributing factor in this mishap. The gray metal light pole blended in with the gray overcast skies. Even though pilots are aware of the hazard that obstacles represent, individuals may momentarily let down their guard if an obstacle does not stand out sufficiently from the surroundings. This is more likely to occur when the pilot is hungry, tired, stressed, or distracted.

Obstacle Marking - Marking obstacles that lie in or near operational areas is an extremely important consideration. This is particularly true when the obstacle may blend in with the background under certain conditions. Heliport designers should consider marking obstacles with reflective materials, flood lights, or obstruction lights (reference 8). Using reflective tape or paint to place stripes on an obstacle may be the simplest means of making obstacles more visible.

Obstacle Location - Operational areas may contain obstacles such as fences, poles, or other aircraft. Placing permanent obstacles in or near operating areas must be done with care and consideration. At airports, helicopters typically operate in areas designed primarily for fixed-wing use (parking, fuel, taxi). These areas are often designed without considering any special needs of helicopters. A suggestion for installing lights in this

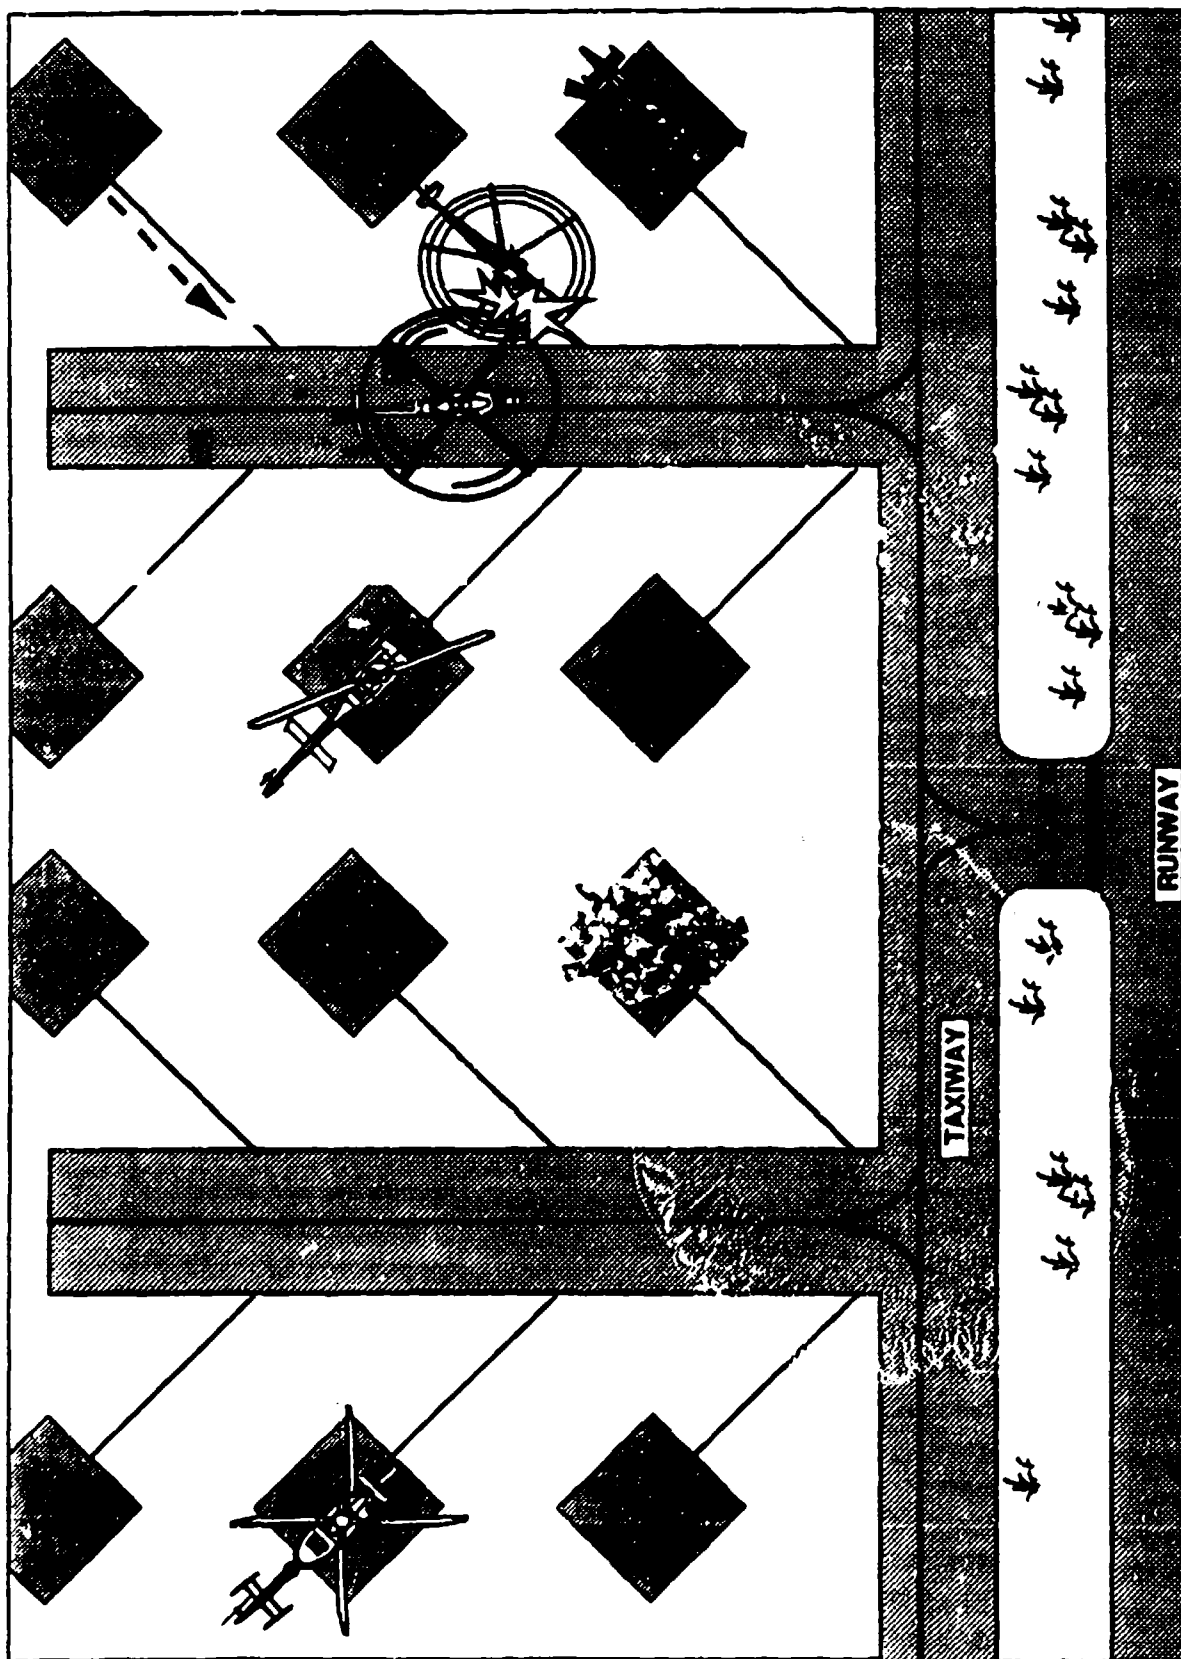
FIGURE 6 OBSTACLE STRIKE - MULTIPLE AIRCRAFT ON-GROUND COLLISION

Visual Obstacles - The single-turbine pilot's visibility was hampered by the curtain that separated the cockpit from the cabin. In most operational situations, the curtain may not have presented a hindrance to the pilot.

However, in this particular instance the design of the parking area necessitated that the pilot be able to see more than 90 degrees to his right.

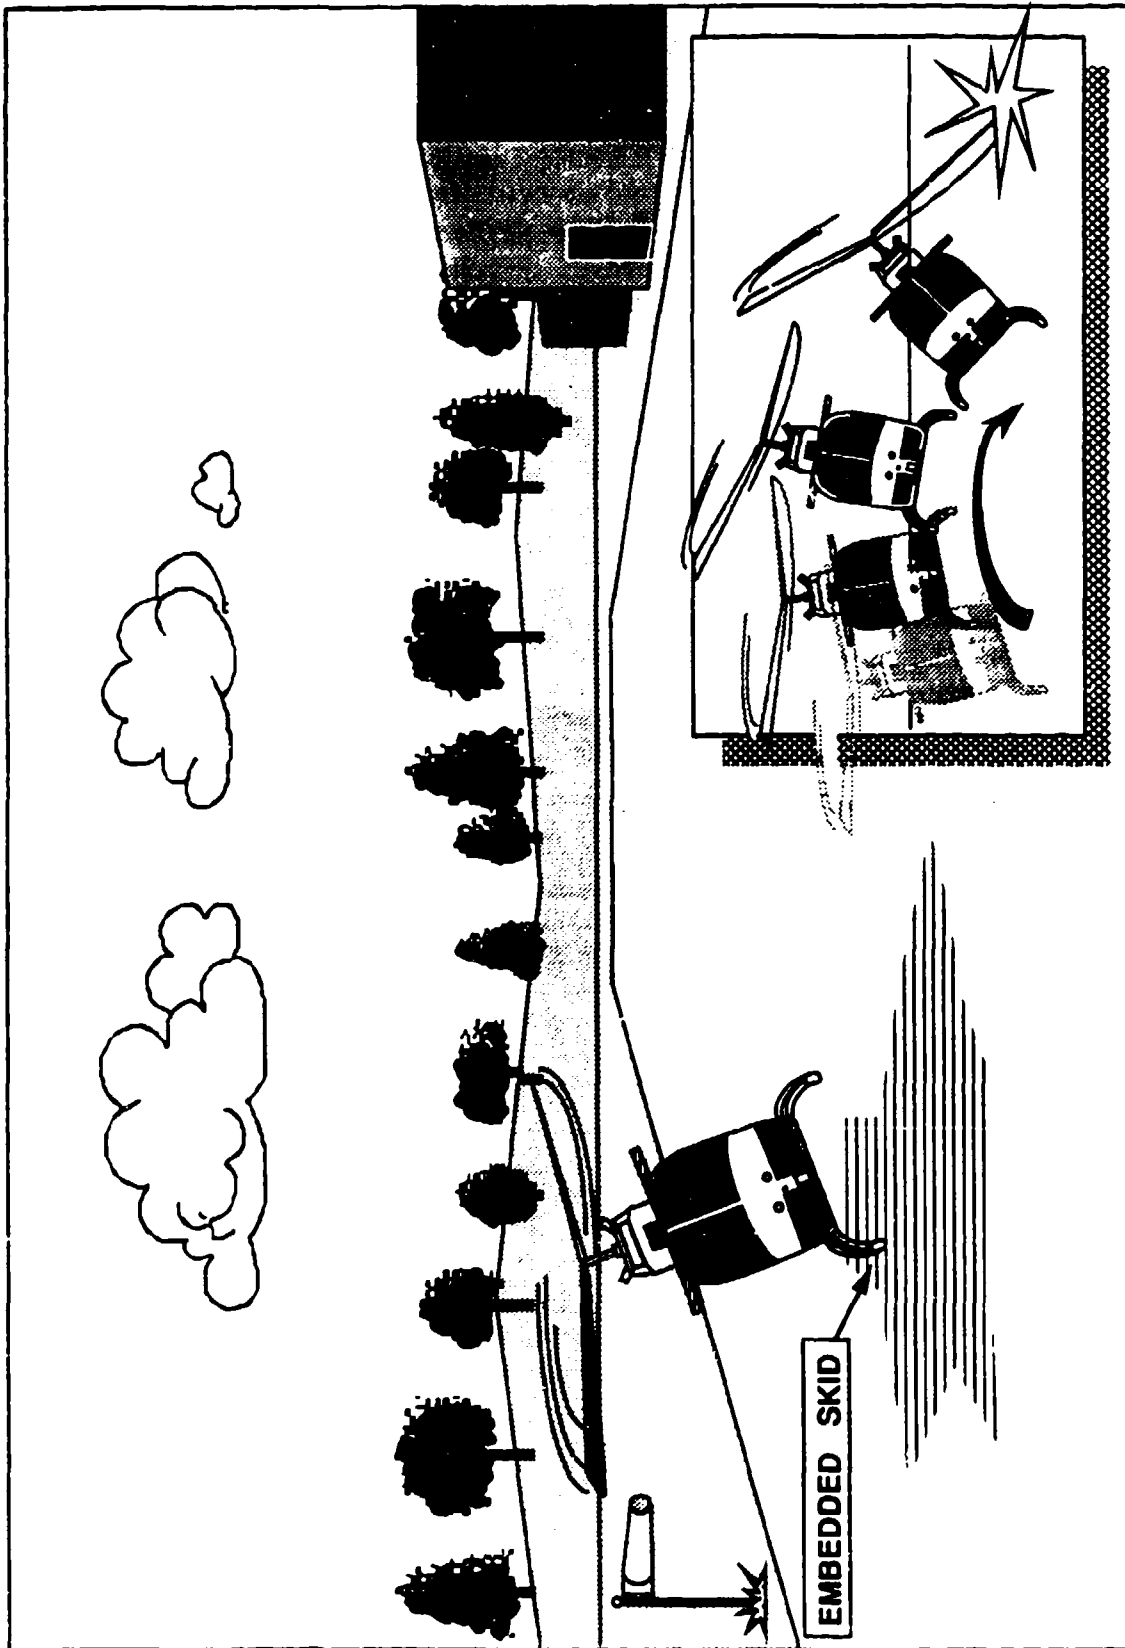
FIGURE 8 GROUND MISHAP (STUCK SKID)

Preflight Procedure - The pilot's preflight procedure was obviously inadequate because he failed to notice that the skid had sunk into the asphalt. The condition of the surface around the skids should always be checked. Any cracks, bumps, or indentations can lead to mishaps.

Pilot Technique - A contributing factor to this mishap was pilot technique. The pilot attempted to free the skid by pulling collective and using the helicopter to fly out of the asphalt. This is not recommended at any time. The best solution to the problem is to physically loosen the landing gear with the engine off during the preflight inspection. Ground handling equipment can be helpful in this regard. Depending on aircraft model, it may also be possible to free the landing gear by moving the tail boom.

Surface Material - It is important that operational areas be capable of supporting the full weight of the aircraft. These areas include FATOs, refueling areas, and parking pads. Concrete is preferable to asphalt. This is particularly true for locations that experience high daytime temperatures during the year. Figure 9 depicts the heliport with design improvements that enhance safety.

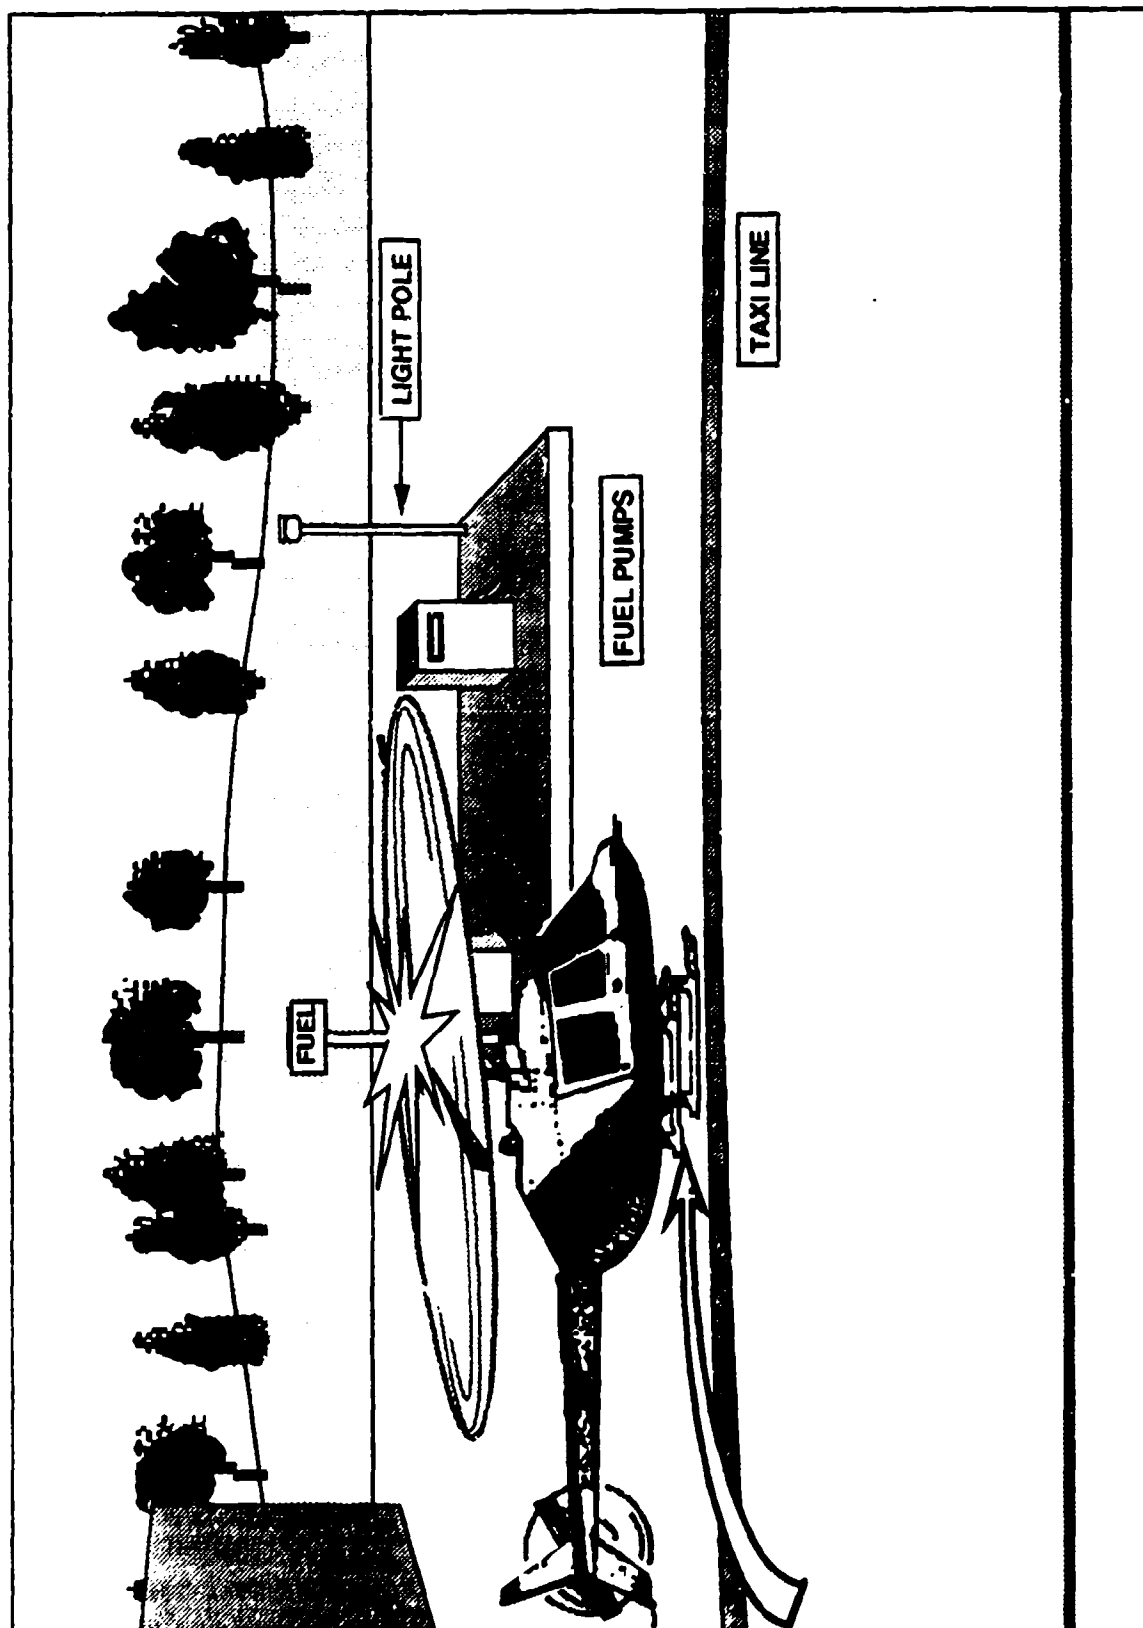
FIGURE 10 OBSTACLE STRIKE - SIGN POLE

Refueling Hoses - Pilots have stated in mishap investigations that their concern over the length of fuel hoses has been a definite contributing factor to mishaps. In their attempt to get close enough to the fuel pumps,

their helicopters have struck objects in refueling areas. Refueling hoses should be adequate in length so that an aircraft centered on the taxi line can be refueled. Pilots should not have to concern themselves with the length of a fuel hose. Taxi lines adequate to handle the largest type of helicopter should be marked. However, for the uninitiated, a short sign could be posted, "Fuel - 40 Foot Hose."

Ground Markings - At refueling areas that include service for helicopters, taxi lines must clearly provide adequate clearance for safe operations. That is, if large helicopters may not operate safely in these areas, it should be clearly indicated as such. One method may be to post the largest rotor diameter accommodated on the taxi line. If taxi lines are meant as a guide to fixed-wing aircraft only and are not meant for helicopters, then it should be noted as such. Figure 11 depicts the heliport with design improvements that enhance safety.

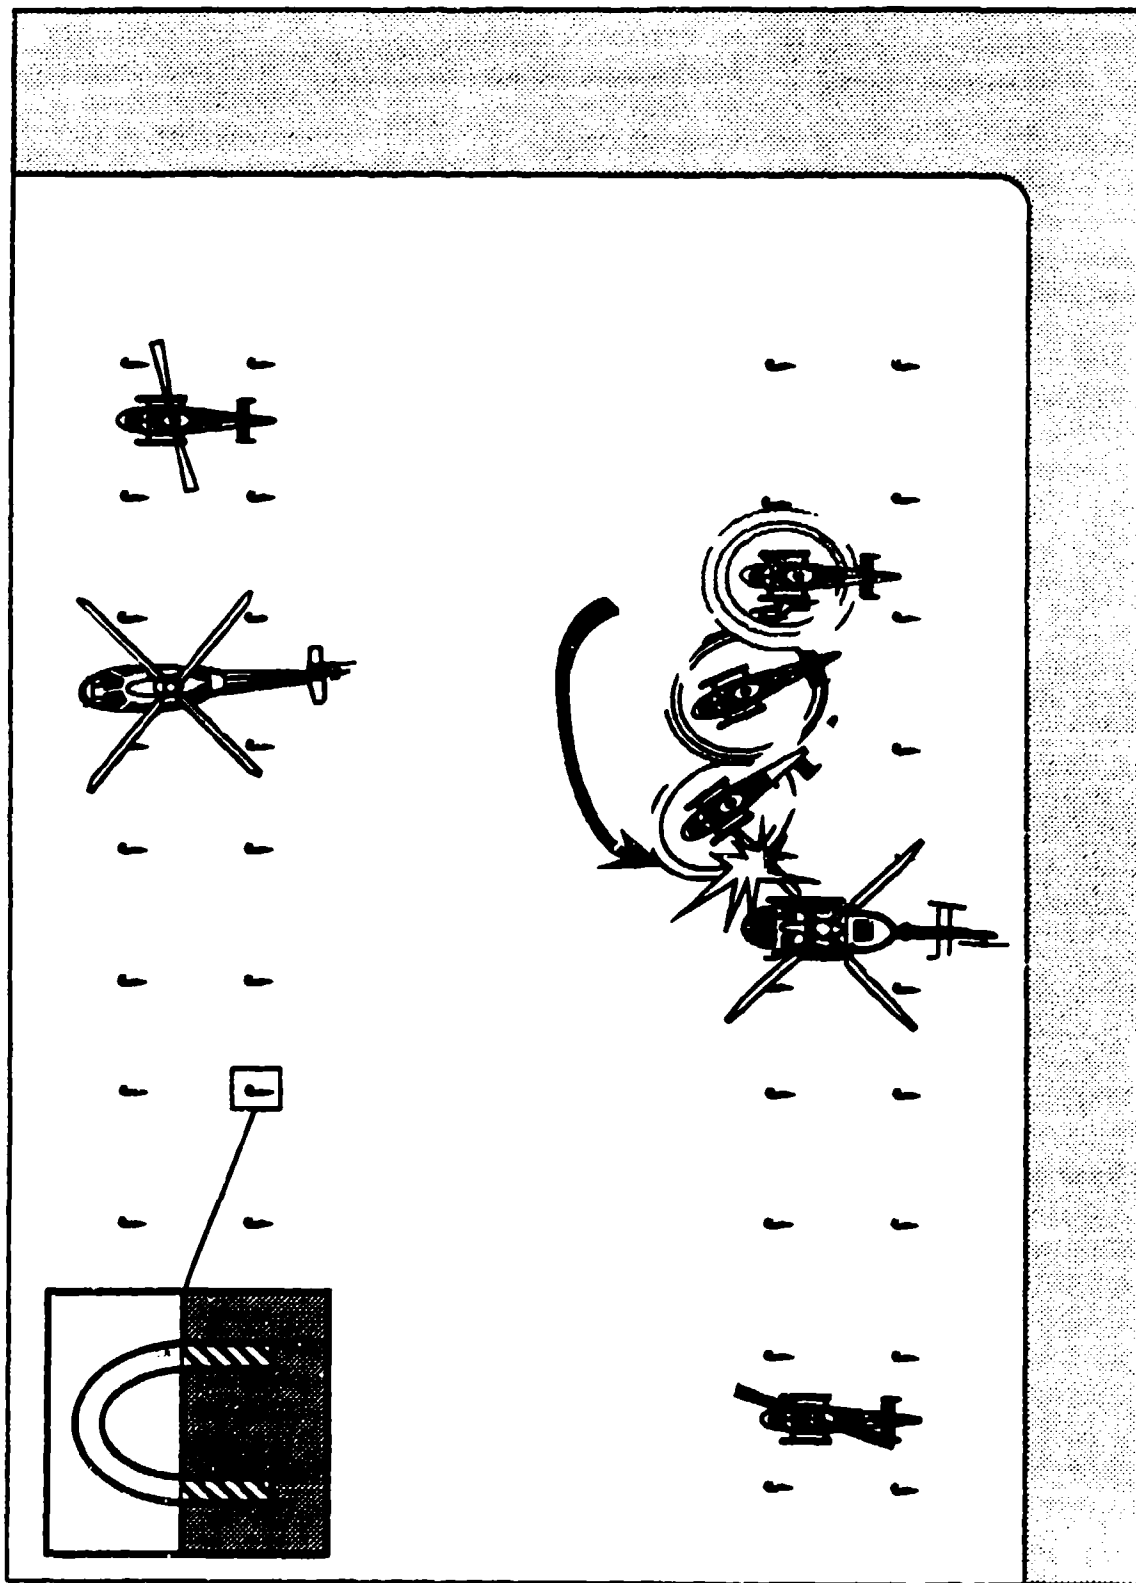
FIGURE 12 OBSTACLE STRIKE - TIE-DOWN ANCHOR

In post-mishap interviews, the pilot stated that because of the excitement of taking her friend for a helicopter ride, she forgot about the anchor bolts. She also stated that the bolts were not easily visible at night. The owner of the FBO stated that he didn't consider the anchors to be a real hazard, because they only "stuck up about 2 inches above the parking ramp."

Lighting - The parking area was not well lit. Had the area contained better lighting, this mishap may not have occurred. Lighting was especially important in this mishap, since the parking area contained obstacles (anchor bolts) that were not easily seen at night.

Flat Operating Surface - Helicopters require flat operating surfaces. Mishap data shows that just about any object protruding above the operating surface has the potential for causing a mishap. Helicopters have caught landing gear on objects such as grounding eyes, bolts, drainage grates, perimeter lights, and helipad lips. Although an object may not appear to be a hazard, it is important to recognize that any object that protrudes above the operating surface represents a potential cause for a mishap. This design consideration is important even when the helicopters using the facility are equipped with wheeled landing gear. Figure 13 depicts the heliport with design improvements that enhance safety.

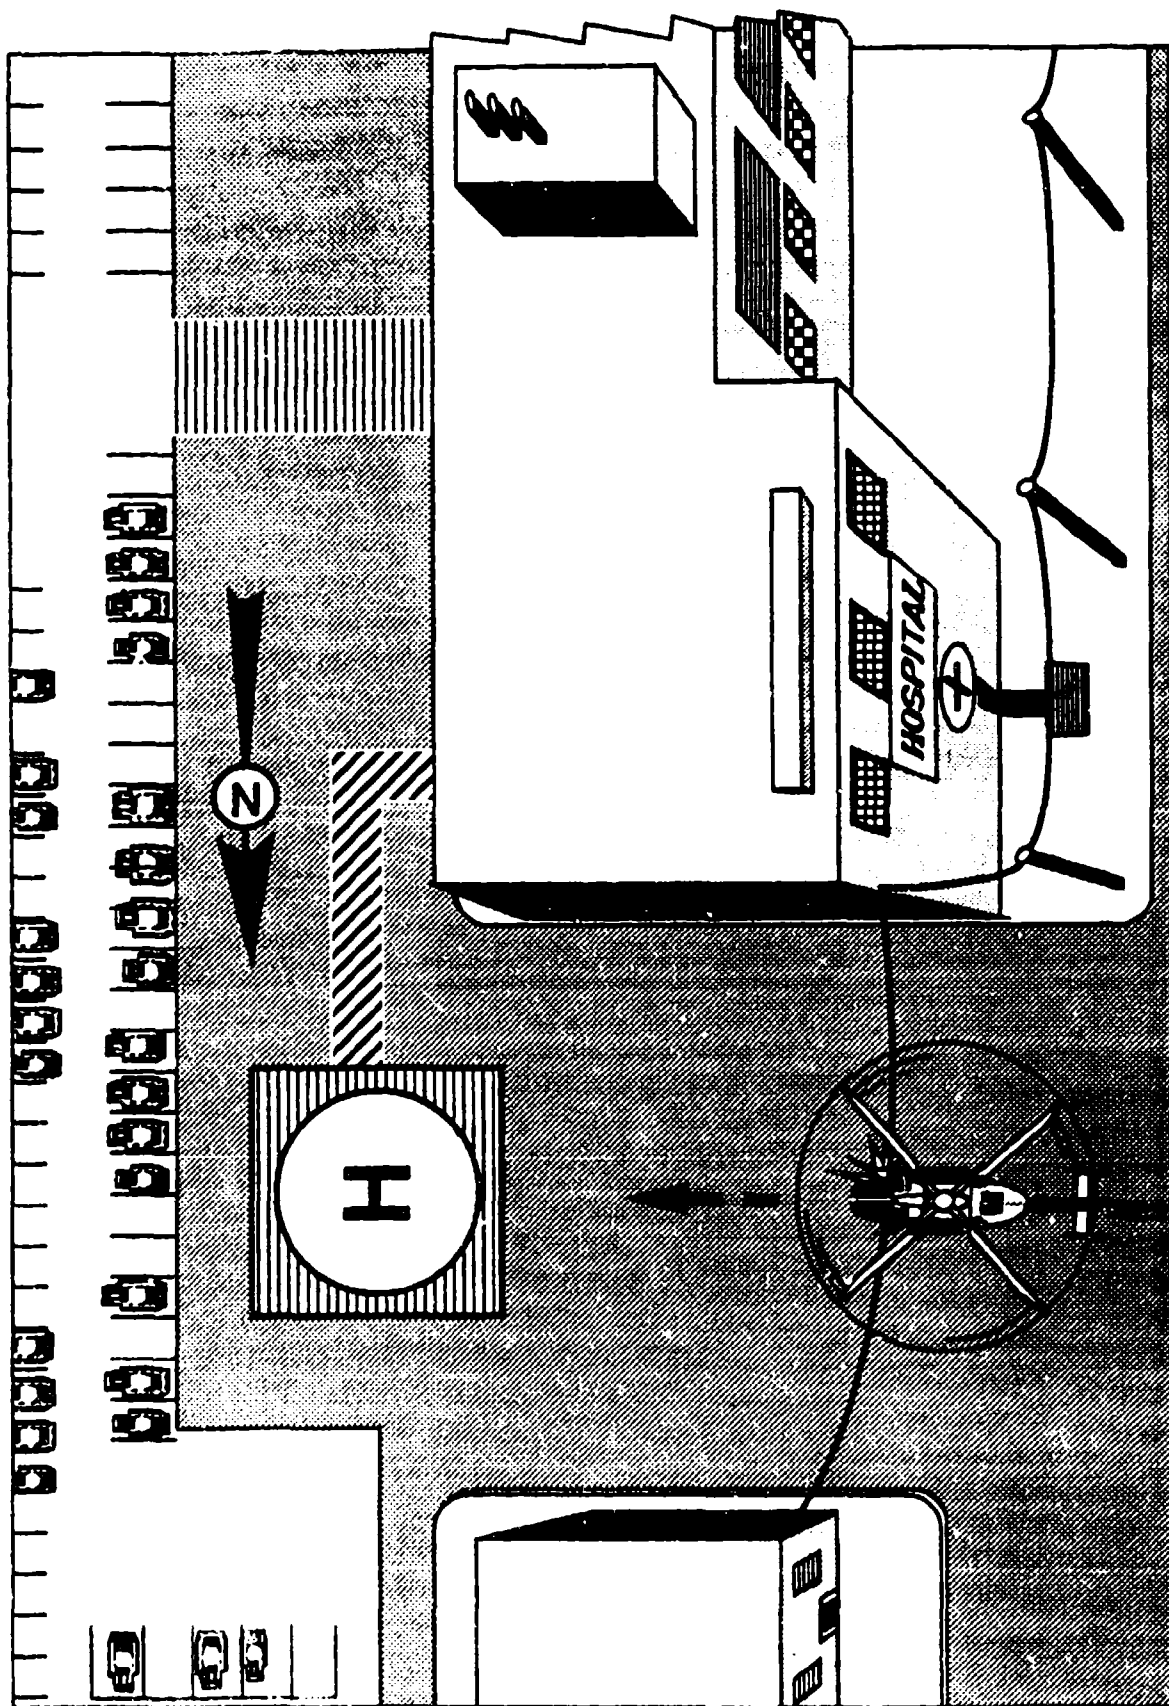
FIGURE 14 OBSTACLE STRIKE - WIRES

Obstacle Marking - Although the wires were located below the 8:1 protected airspace surface, they remained hazardous to operations. They were difficult to see because they blended in with the background. The mishap analysis report (reference 1) provides guidance for marking wires near heliports which lie below the 8:1 protected surfaces.

Obstacle Location - The fact that the powerlines were located below the approach/departure protected airspace surface did not preclude them from being a hazard to operations. Mishap reports indicate that wires located near heliports have contributed to many helicopter mishaps. Installation

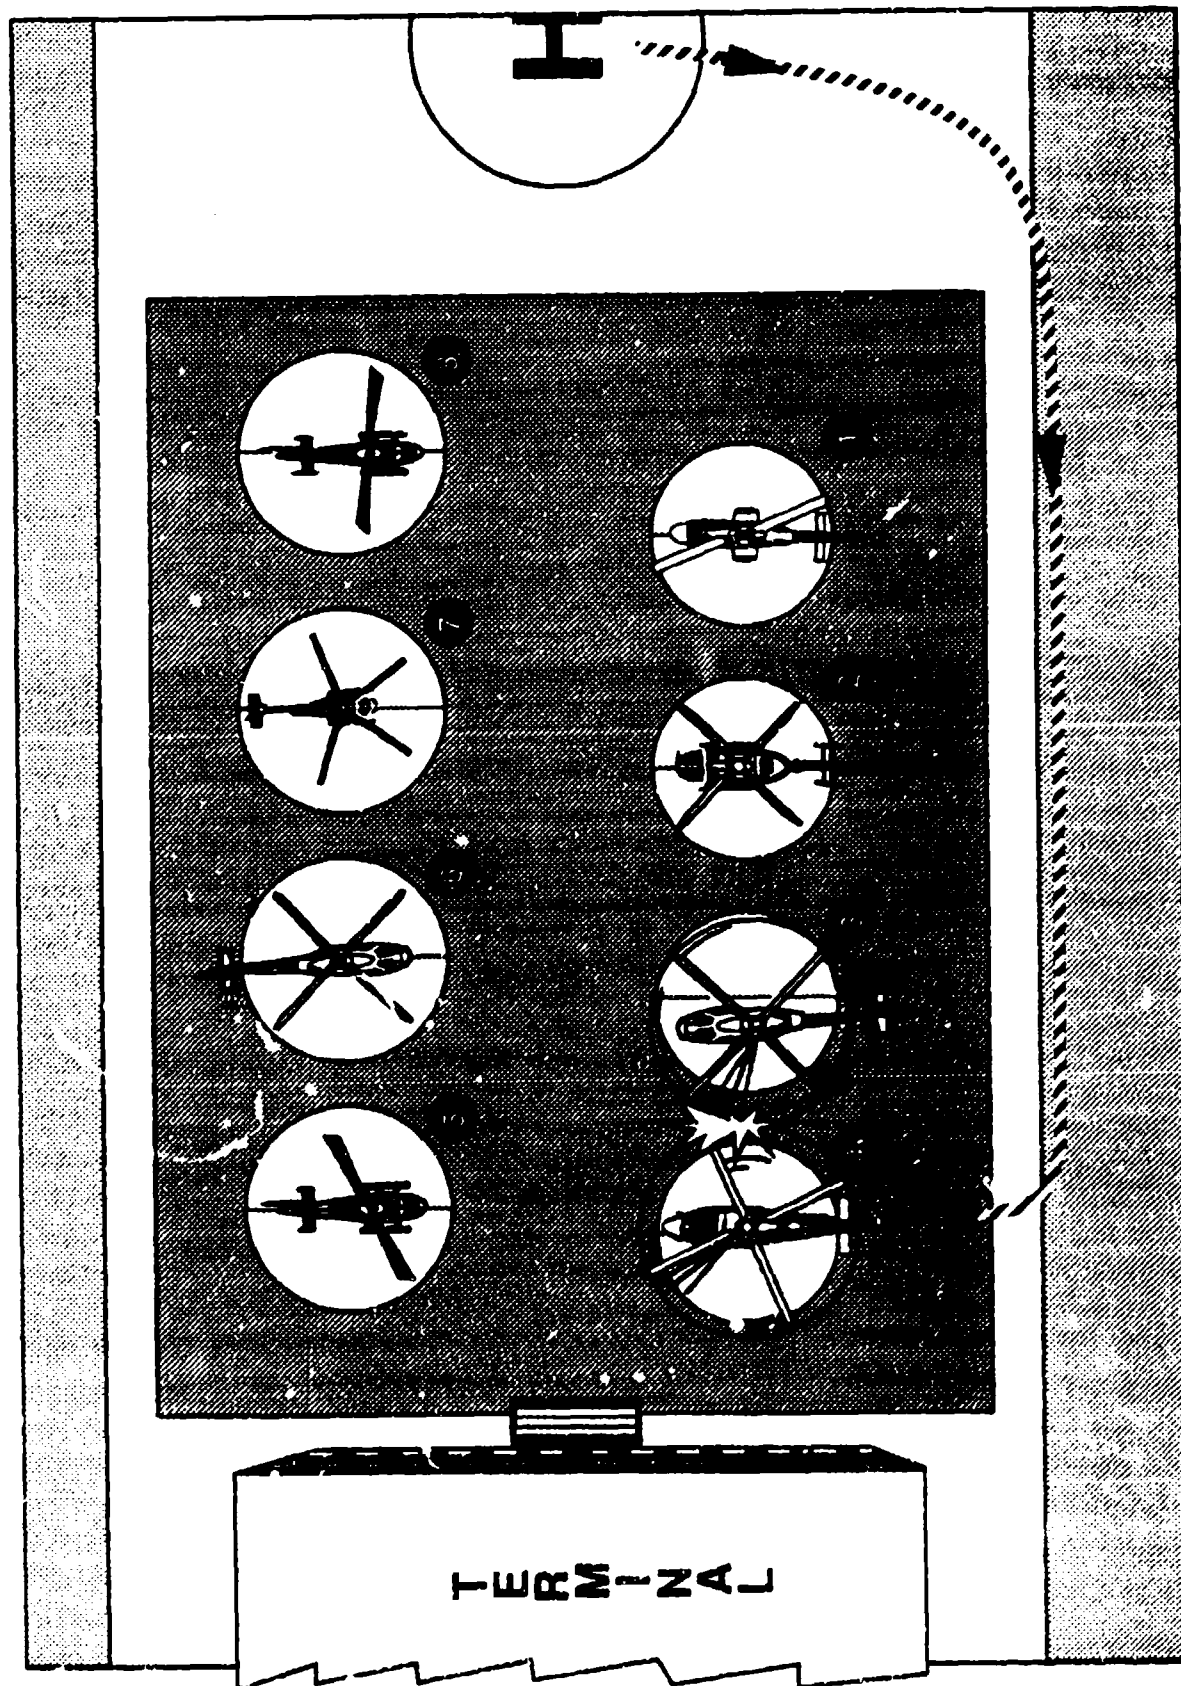
FIGURE 16 MULTIPLE AIRCRAFT - MAIN ROTOR BLADE CONTACT (ON-GROUND)

After the blade contact, the first helicopter was observed to be about 5 feet left of the parking space centerline and the second helicopter was about 1 foot to the right of its designated parking centerline. Both helicopters incurred substantial damage. There were no injuries to the crewmembers, passengers, or line personnel. There was no fire and no other damage as a result of the mishap.

Marking - The fact that both helicopters parked off the parking space centerline contributed to the cause of the accident. To facilitate placement of the aircraft at the center of the parking space, centerlines and cross lines need to be clearly marked and visible to the pilot of a taxiing helicopter. Figure 17 depicts the heliport with design improvements that enhance safety.

Parking Area Clearances - The helicopter parking area should allow adequate clearance for adjacent parking of the largest design helicopters. The current Heliport Design Advisory Circular 150/5390-2 (reference 3) recommends "at least 1/3 rotor diameter but not less than 10 feet (3 meters) clearance from a takeoff and landing area or a fixed or movable object." This indicates the need for a clearance between the edges of parking spaces of 1/3 rotor diameter of the largest helicopter expected to use the heliport. As illustrated by this mishap, parking safety can be compromised even with specified parking space/aircraft assignments.

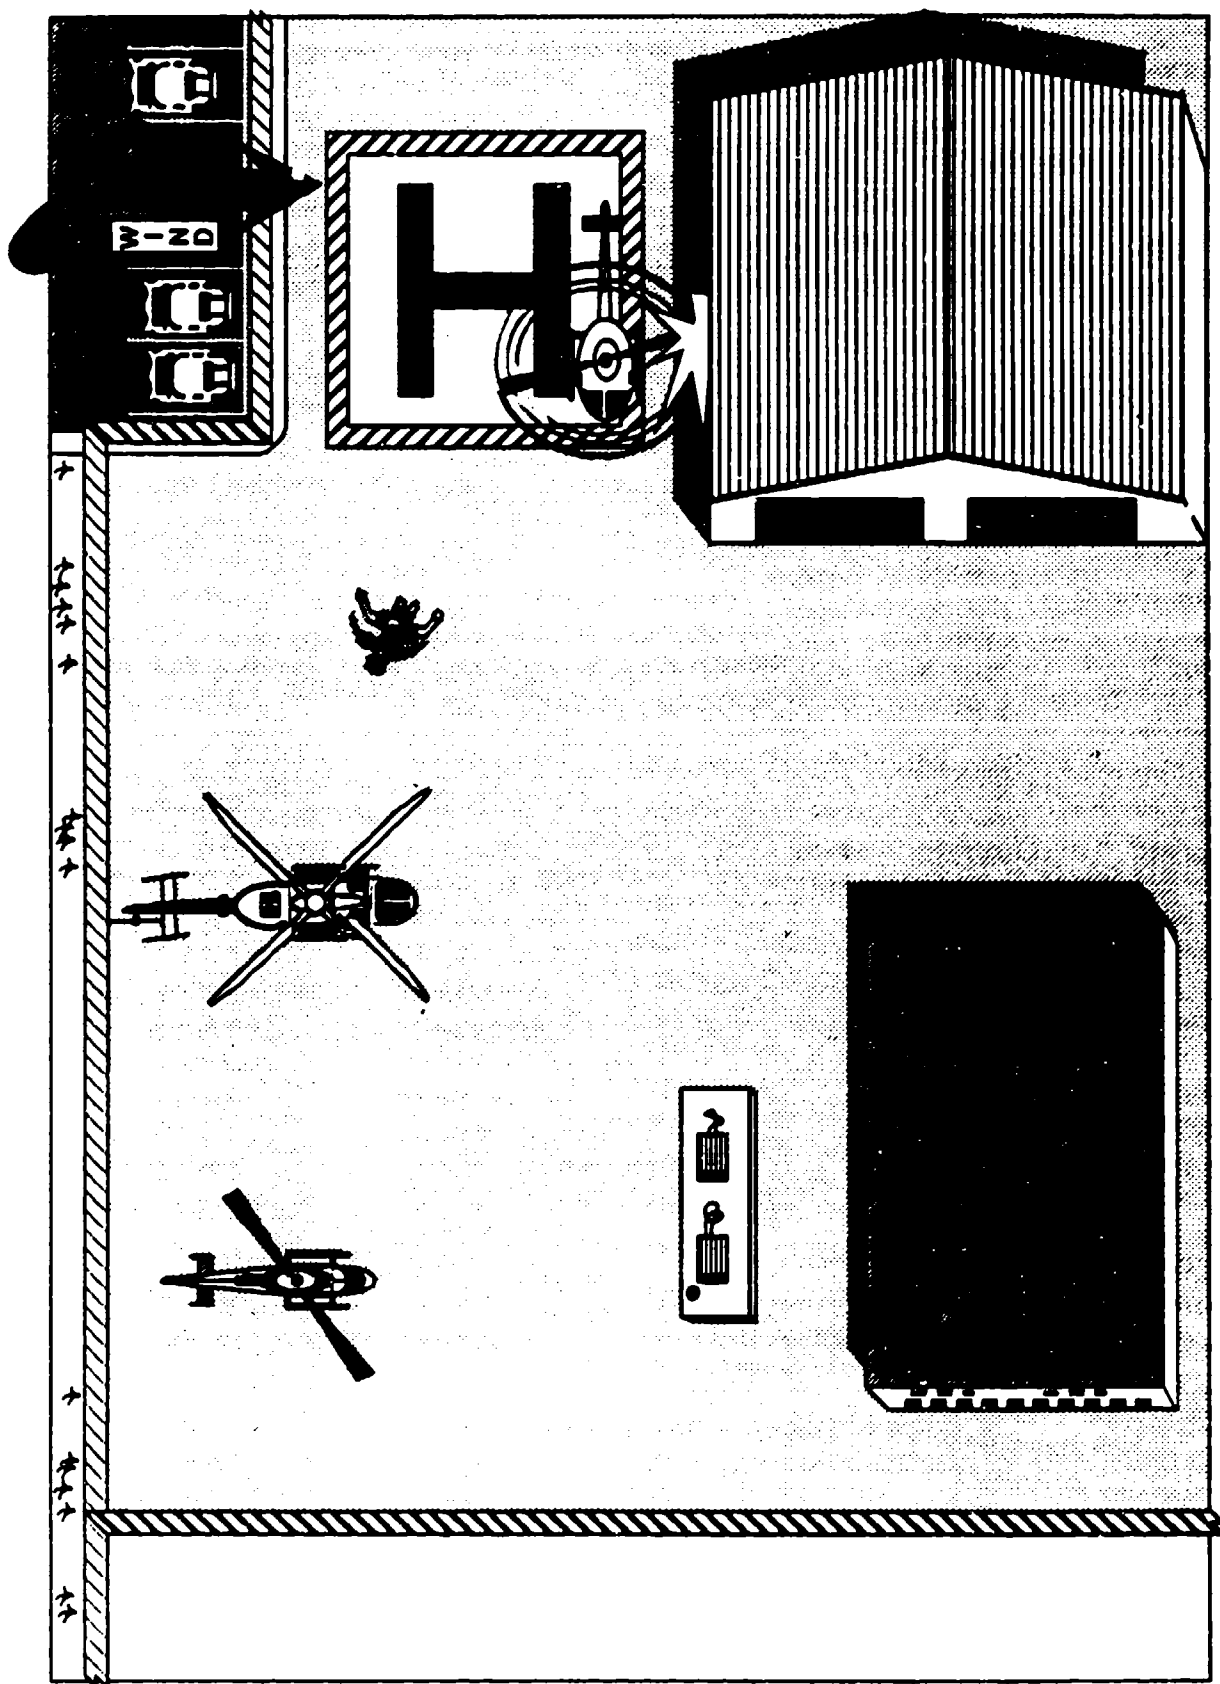
FIGURE 18 OBSTACLE STRIKE - BUILDING

Upon liftoff from the FATO, the pilot reported that his attention was diverted by the proximity of parked automobiles and the activity in the parking area. A sudden gust of wind blew the helicopter into the hangar (see figure 18). Flying debris struck a ground support crewman standing nearby. He was taken to a local hospital in critical condition with head and leg injuries. The pilot exited the helicopter uninjured, although the helicopter was substantially damaged.

Wind Effects on Operations near Buildings or Other Obstacles - Windflow, gusts, and the potential for sudden changes in aircraft handling in sudden

wind changes need to be anticipated, both in heliport design and in operational situations. Several mishaps in the NTSB files that were analyzed illustrated the hazards of operating in proximity to large obstacles and the effects the wind can have during such operations.

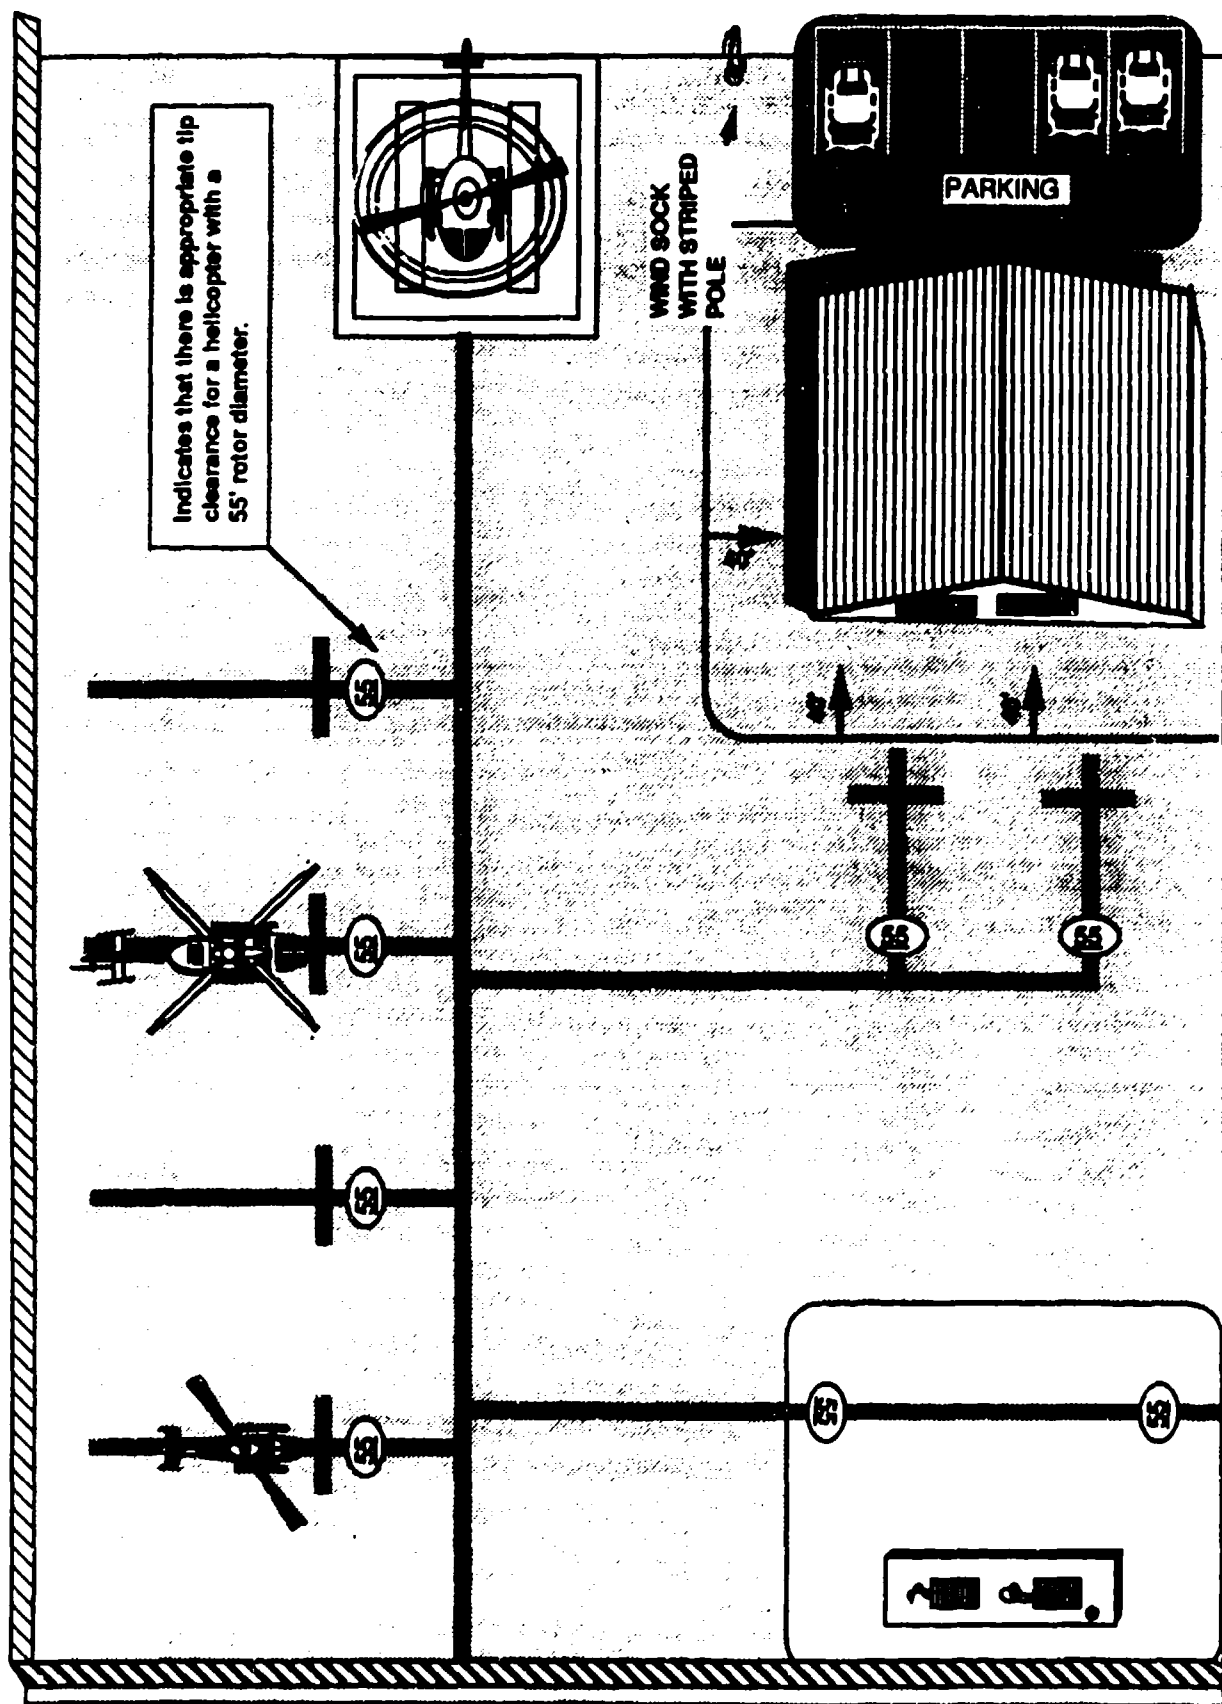
FIGURE 19 IMPROVED HELIPORT DESIGN - LOCATION OF THE FATO

FATO Size - The operation occurred in an area that was well below recommended design standards. As previously mentioned, the edge of the FATO should be located at least 1/3 rotor diameter, but not less than 20 feet, from structures. Recent FAA analysis has raised questions whether the 1/3 rotor diameter tip clearance is adequate for small helicopters. The helicopter requiring the largest tip clearance may be the small, light helicopter that is more easily affected by wind gusts than larger, heavier helicopters.

Specified "Clear the Pad" Rules - Normal safe operating procedures would dictate that no personnel are allowed in the vicinity of departing and arriving helicopters. At the very least, a hard-and-fast rule specifying that no personnel be allowed on the pad during liftoff and touchdown seems

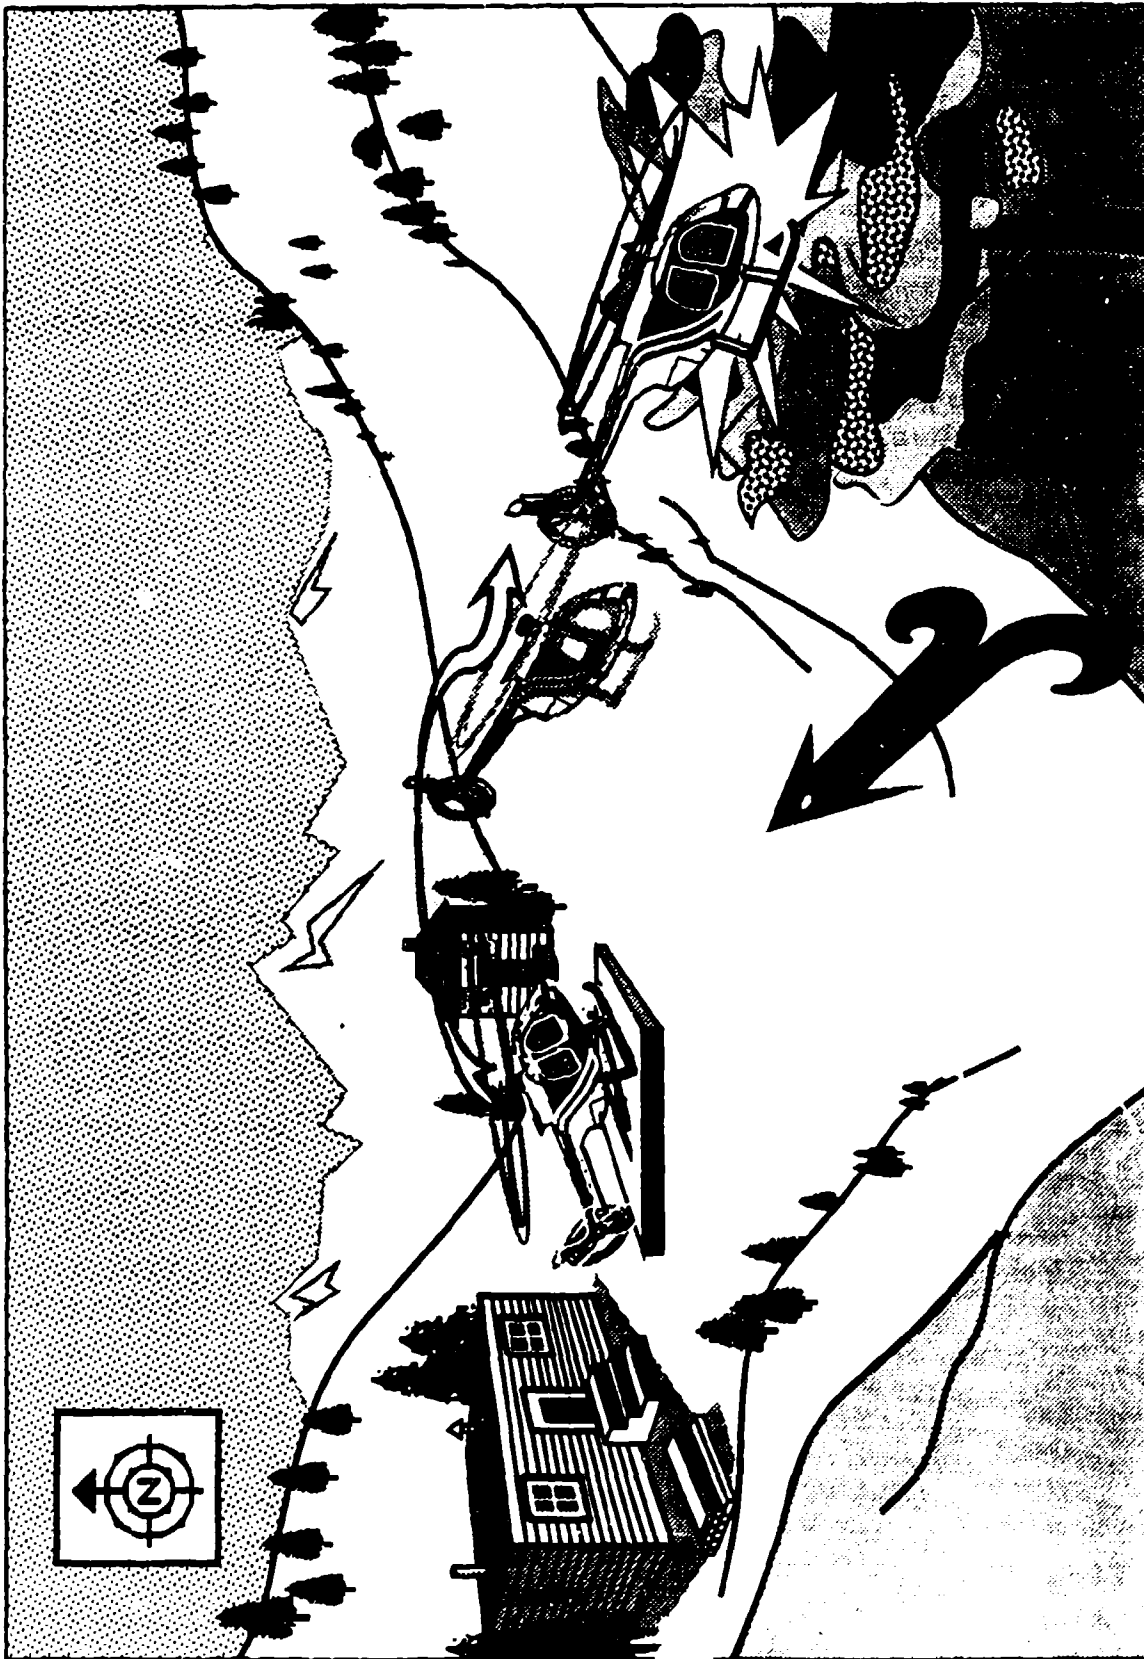
FIGURE 20 INSUFFICIENT POWER FOR TAKEOFF - DENSITY ALTITUDE

Pilot Technique - The pilot's takeoff procedures in this situation contributed to the mishap. The operating area was rather tight and the density altitude was questionable. In this situation, the pilot should have been near maximum takeoff power at takeoff, rather than waiting to apply full power.

Rejected Takeoff Groundspace - Rejected takeoff mishaps may occur at any altitude; however, the likelihood of this occurring is increased at high
